Clinical Note

Size "H" Oxygen Cylinder: Accidental MR Projectile at 1.5 Tesla

Patrick M. Colletti, MD

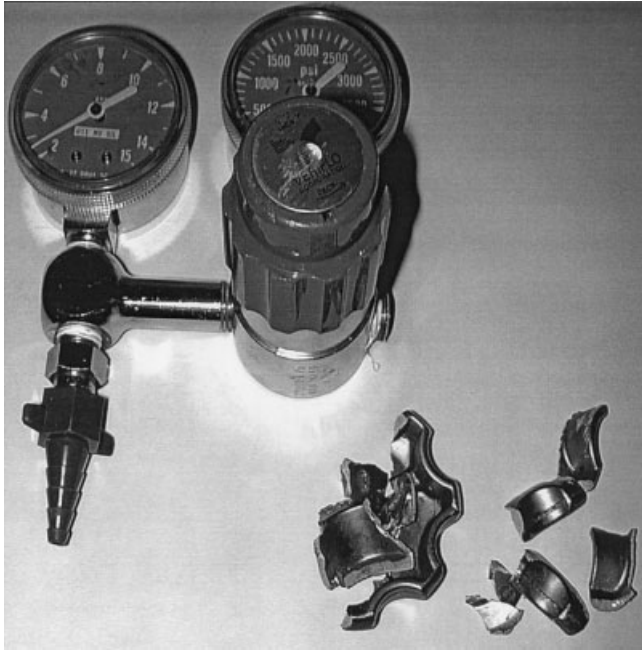
The flow regulator (Fig. 1) was sheared off of the cylinder (Fig. 2) and the cylinder impaled the scanner cowling at the one o'clock position (Fig. 3). The cylinder oscillated precariously, pivoting on the point of impalement. The physician and technologist were able to help the technologist assistant move past the nearly stable cylinder. At that point, in order to stabilize the cylinder and extract the uninjured but hypoxic patient, the chief technologist decided to perform an emergency ramp down of the system. The system ramped down to a negligible field in less than two minutes. With this "controlled quench," helium rapidly escaped via the overhead safety vent. The vent cap was damaged during this process and required replacement prior to cryogen refill. The in-room oxygen level monitor did not detect reduced oxygen levels. Within two minutes of the incident, as two assistants controlled and carefully removed the cylinder, the patient was removed from the magnet. She responded rapidly to oxygen administration.

Figure 1. The flow regulator that was sheared off of the cylinder and the nonferromagnetic valve handle that fragmented upon impact with the table.

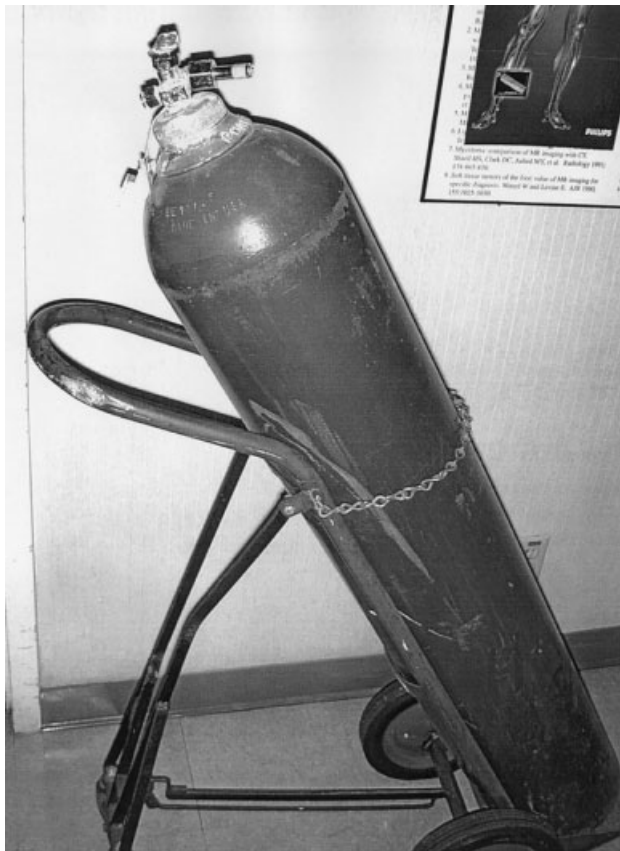
Figure 2. The size "H" oxygen cylinder after the regulator was sheared off. Note the scrapes on the cylinder and the bent beam on the cart.

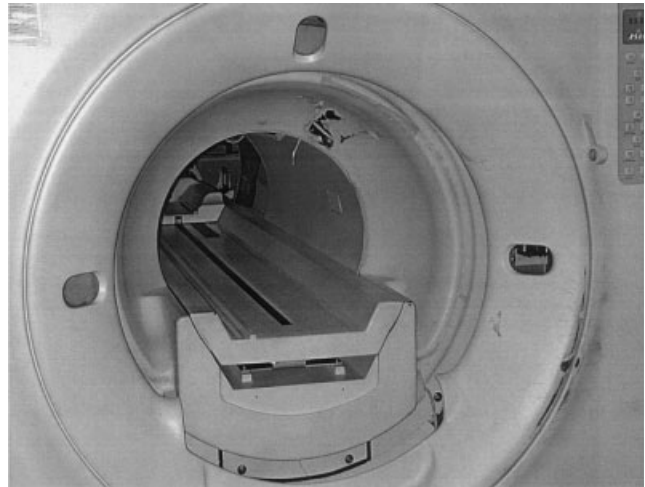
1. A 15-cm hole in the magnet cowling (Fig. 3); the cowling had to be replaced.
2. The 1600-lb gradient coils were displaced 1 cm and were rotated slightly; special tools were required for adjustment.
3. The scanning table was damaged; replacement was required, at a cost of \$8000.
4. The quenched magnet required an emergency fill of 600 liters of liquid helium (five flasks of 120 liters each), at a total cost of \$10,000.
5. Emergency after-hours service: 60 person-hours; at a cost of \$93,000.
6. Use of the scanner was lost for 34 hours.

Figure 3. This 15-cm hole in the magnet cowling required the replacement of the cowling.

Magnetic projectile events require an appropriate response (4). Since this event occurred, we instituted major policy changes (5–8). All oxygen tanks have been replaced with nonferromagnetic cylinders. Due to the possibility of an erroneous cylinder exchange in the future, all cylinders are also tethered to the ground. All visiting personnel are required to complete and sign a one-page screening form covering potential risks to the visitor and others (9).
