## MRI Safety 10 Years Later

*What can we learn from the accident that killed Michael Colombini?*

**By Tobias Gilk, M.Arch. HSDQ, and Robert J. Latino**

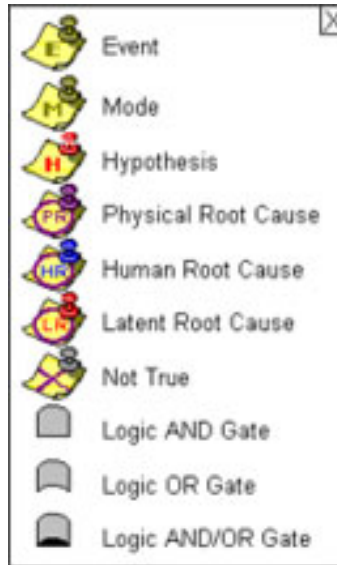
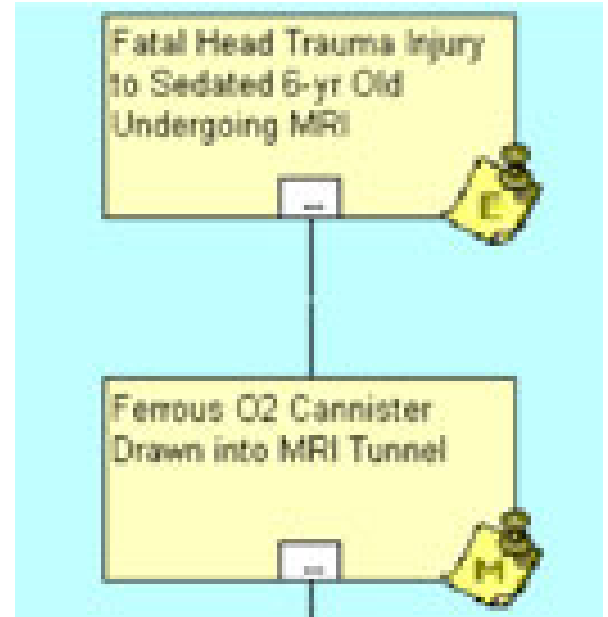
Figure 1: Colombrini Logic Tree Event and Mode

Our logic tree starts with an Event (E). The Event is the last effect in a chain of cause-and-effect relationships. The Event is a fact. At this point we ask "How did the event occur?" The answer is labeled M for 'Mode.' (Figure 1).

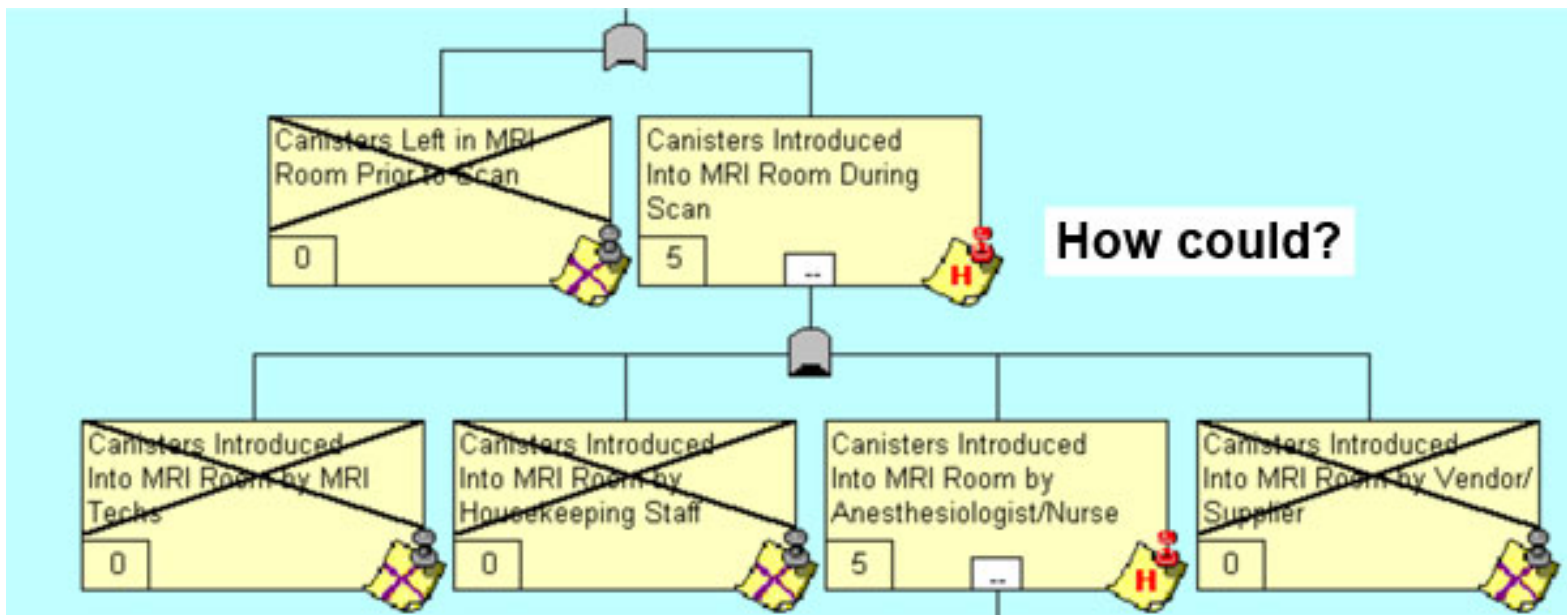
Figure 2: 'How Could' Questioning Process

By asking, "How could the ferrous O2 canister have been drawn into the MRI tunnel?" we hypothesize that either the canisters were left in the MRI room prior to the scan or the canisters were introduced into the MRI room during the scan (Figure 2).

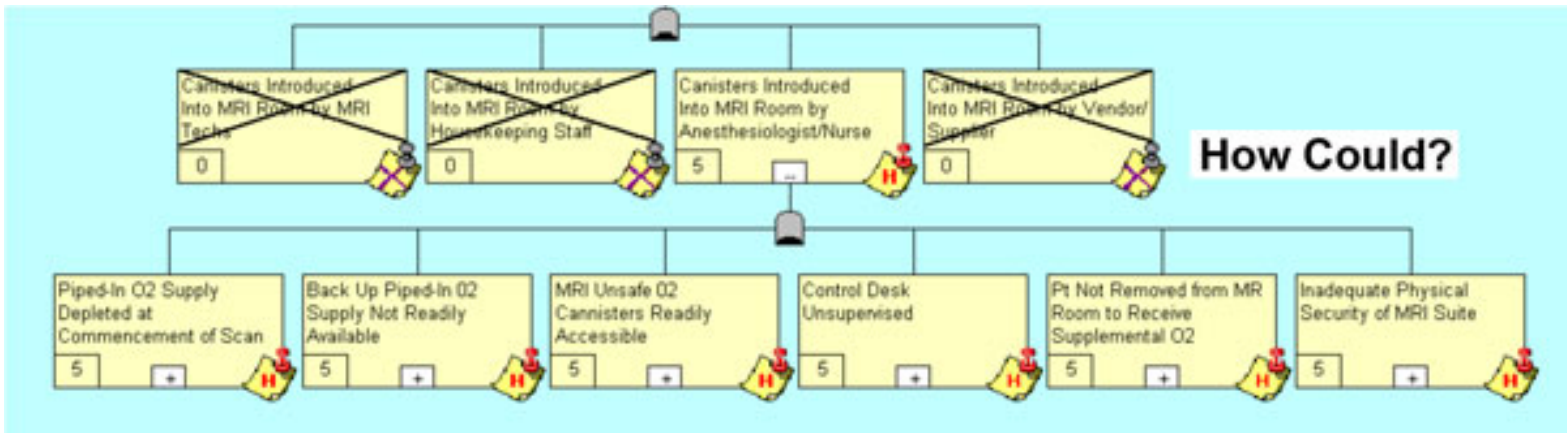
**Figure 4: The Next Level of 'How Could' Questioning**

So the questioning and validation process continues as we progress backwards in time and re-create the path of failure. In Figure 4, we show the next level of questioning and the resulting six paths of simultaneous contribution to the overall incident.

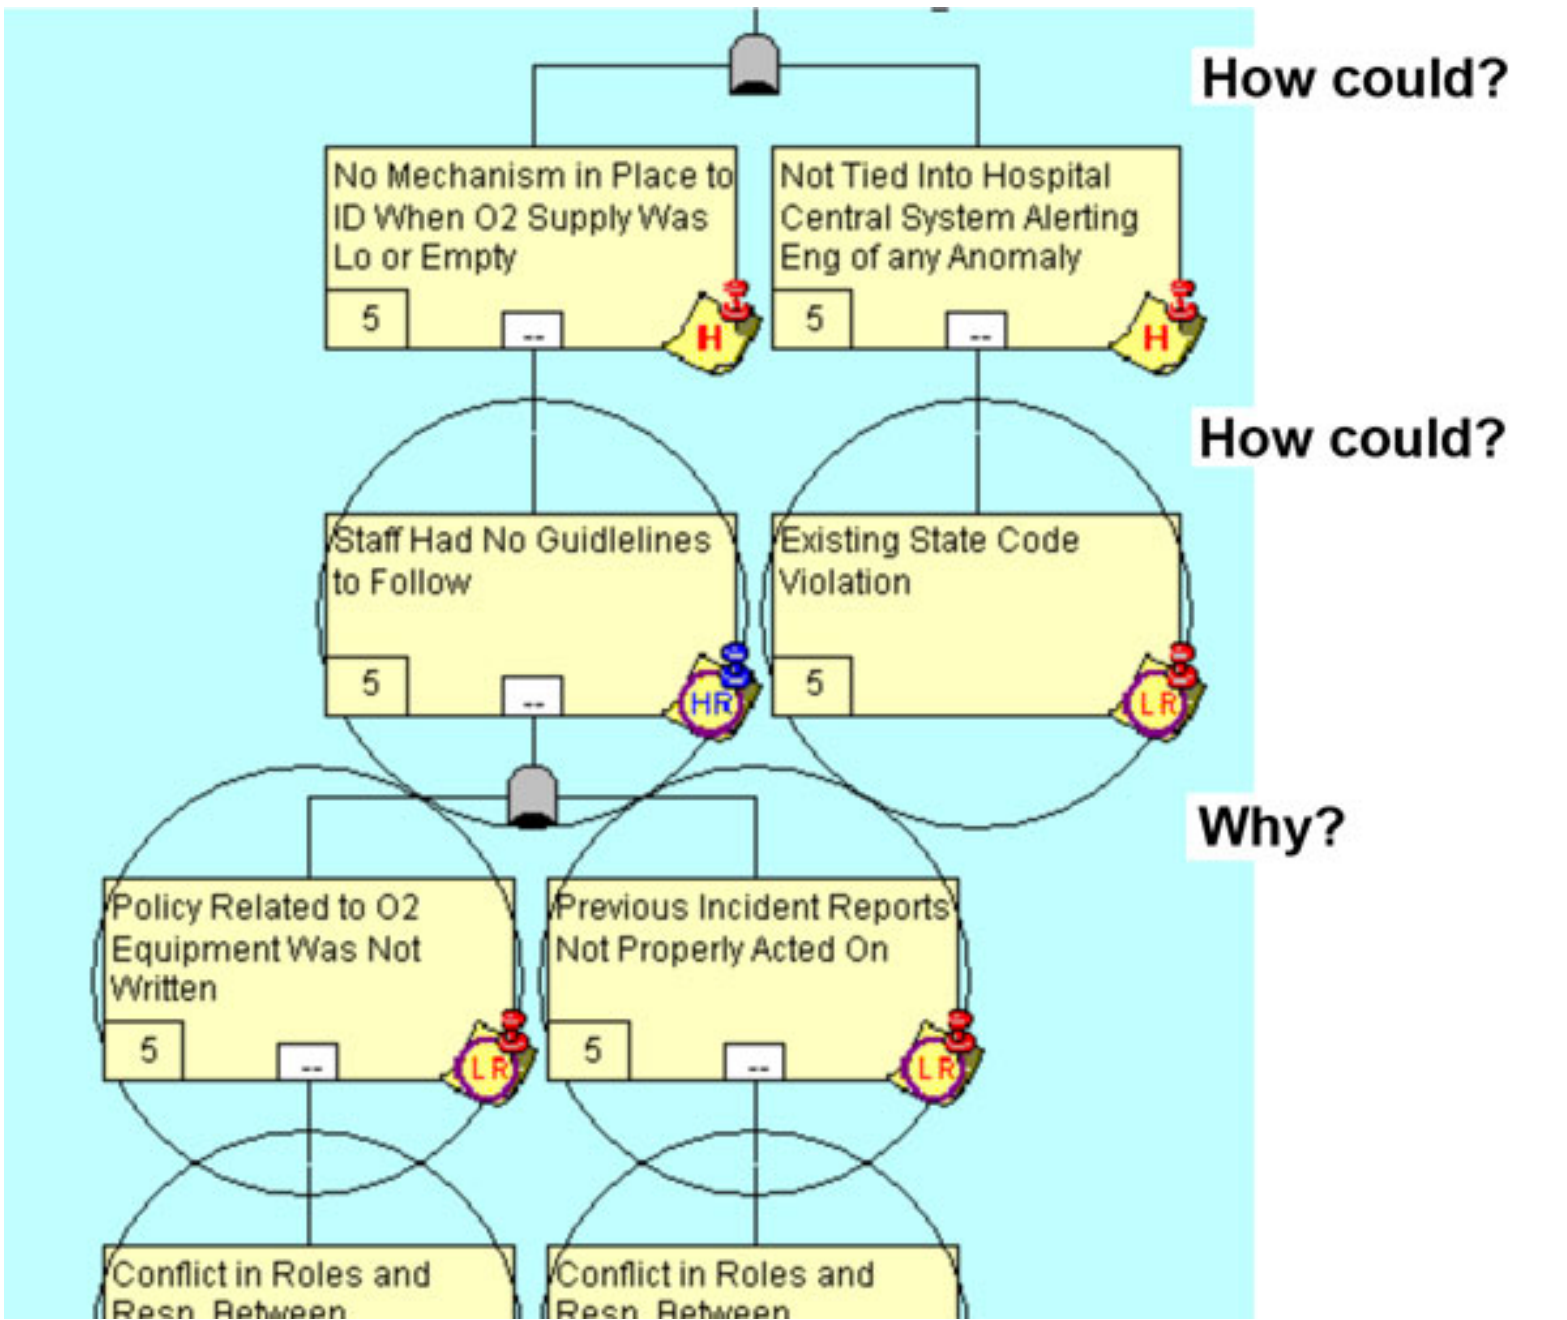
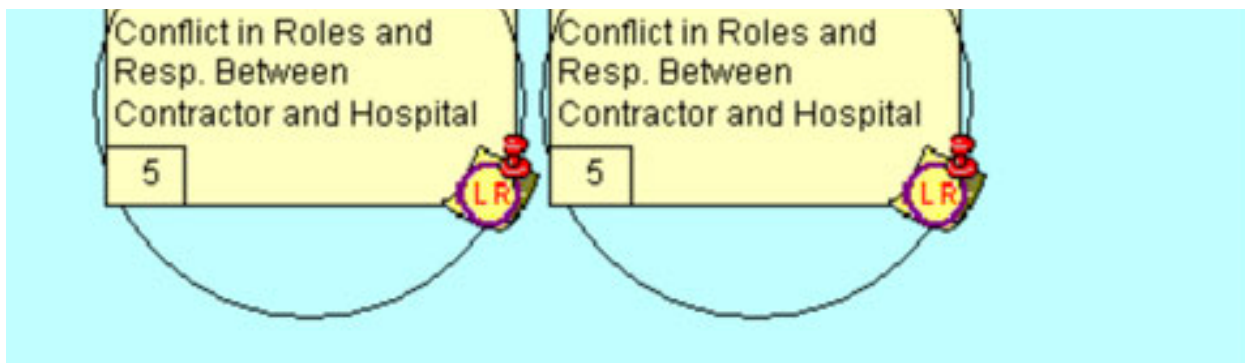
**Figure 5: The Uncovering of Latent Root Causes**

As this questioning process continues, we drill past the symptoms and deeper into the systemic issues that really triggered poor decision-making. By following the "Piped-In O2 Supply Depleted at Commencement of Scan" box we can conclude the string of logic depicted in Figure 5.

In this single string of logic, based on the evidence collected, we see 1) a conflict in roles and responsibilities between the contractor and the hospital and 2) violation of existing state codes.

The conflict in the roles and responsibilities is illuminated in the deposition transcripts, which show that the MRI technologists were unclear on both the immediate responsibility for checking the MRI's bulk oxygen cylinder and the larger issues of whether maintenance and upkeep of the MRI oxygen supply was the responsibility of the hospital or the MRI center. While safety is not inherently compromised when an imaging facility is operated by a third-party contractor, the structural separation between hospital and MRI operations required a level of communication and coordination that was clearly absent in this situation.

Further evidence of this communication gulf was demonstrated when two prior MRI projectile accidents (neither resulted in injury) were discovered to have happened at the same facility in the months and years prior to the Colombini accident. The concealment of these accidents from the State of New York violated the Department of Health statutes, and the failure to communicate prior accidents within the institution (including a prior accident that involved ferromagnetic oxygen tanks, and the remediation step, which included using only non-ferromagnetic oxygen tanks within the MRI suite) contributed to the Colombini accident.

From these causes, a provider could identify a specific set of operational protections. For the failure of the piped-in oxygen system, these operational protections might include:

- MRI staff training on the operation of the medical gas system, including zone valves.
- Established responses for pressure/flow failures of medical gas service, including support from engineering.

- Exercised code procedures, which might include the use of MR-conditional portable medical gas cylinders and/or MRI scanner room evacuation.
