Forensic evidence sheds new light on Swedish MRI accident

March 17, 2020 -- The detailed forensic evidence presented in the 195-page police report on the serious MRI accident in Swedish Lapland contains photos and descriptions of the metallic objects that were effectively turned into flying weapons before they became attached to the scanner.

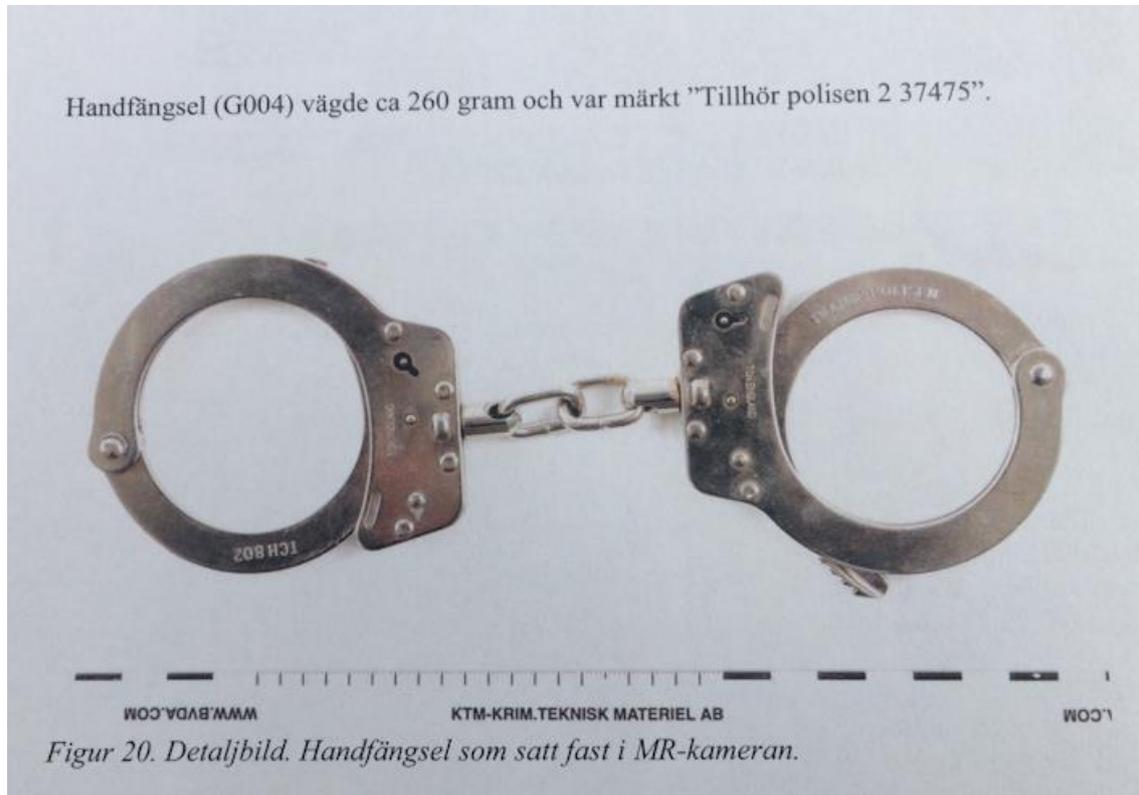
The handcuffs are made by TCH in Birmingham, U.K. The model name/number is TCH 802, and they weigh around 260 grams (almost 9.2 ounces), according to the report.

The British-made handcuffs and aluminum baton found in the mobile unit located outside Sunderby Hospital in Luleå, where the accident happened. All photos courtesy of the Swedish police.

Batong (G003) var ca 34 cm lång i hopfällt läge samt ca 63.5 cm i utfällt läge. Batongen vägde 565 gram och var märkt "Group 4 Falck nr 00129D".

The baton, on the other hand, is 34 cm-long and made from aluminum (but presumably not 100% aluminum). It weighs around 565 grams (20 ounces) and is approved by the National Police Board.

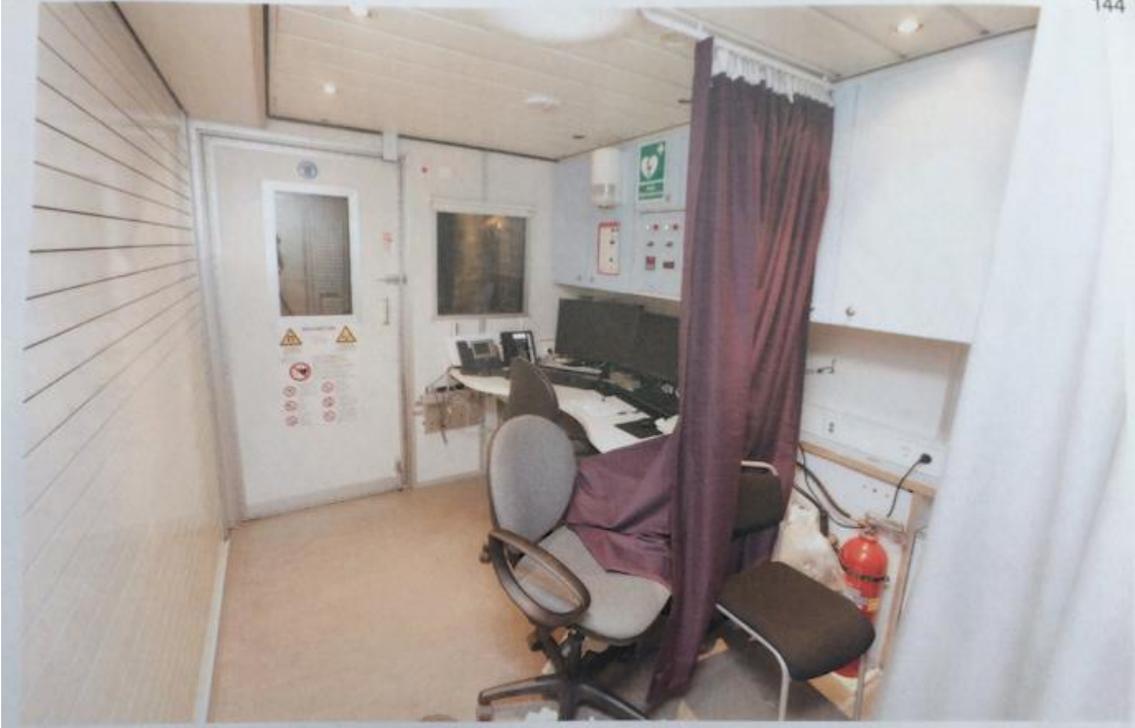
The reporting room in the Aleris-owned mobile unit is shown after the accident happened.

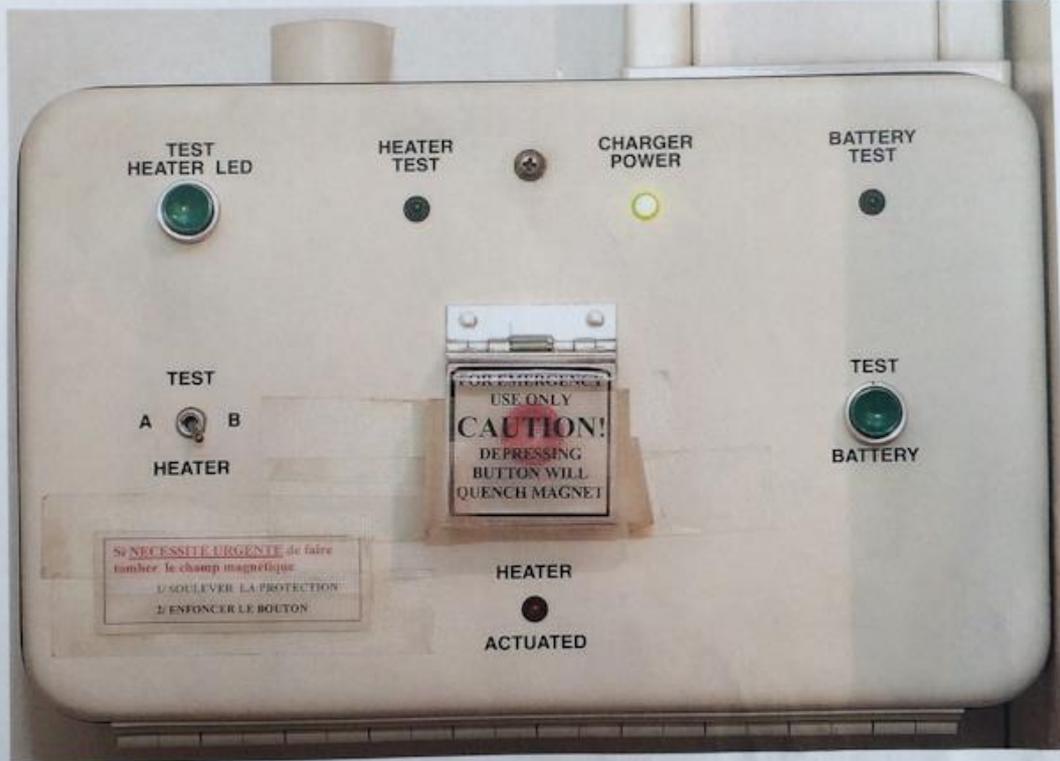
20.

A photo of the emergency button in the mobile unit at Luleå. Quenching a magnet involves turning off the magnetic field, and the button should only be used in a life-threatening emergency. It places the scanner out of service for a week or more, may damage the magnet, and costs over 30,000 euros to replace the lost liquid helium, [MRI Questions](#) explains.

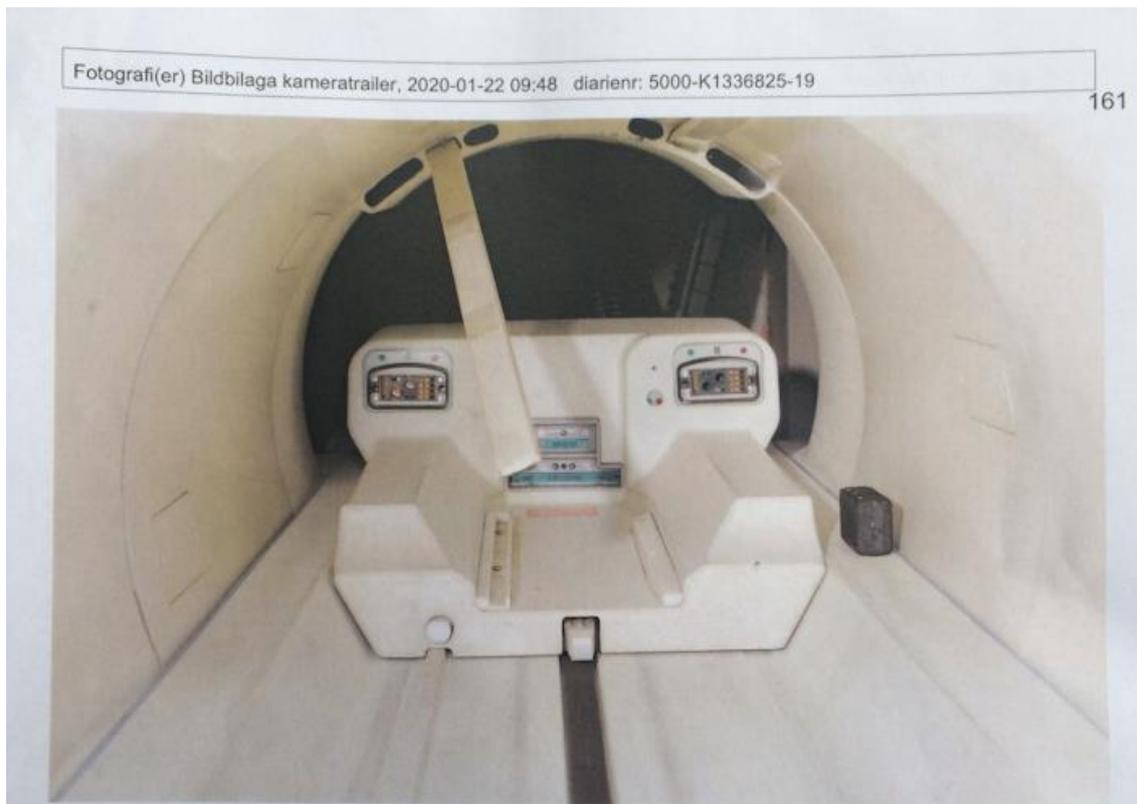
The inside of the scanner gantry in the mobile unit.
