MAGNETIC RESONANCE IMAGING HAZARDS AND SAFETY GUIDELINES

CRITICAL MRI SAFETY EDUCATION

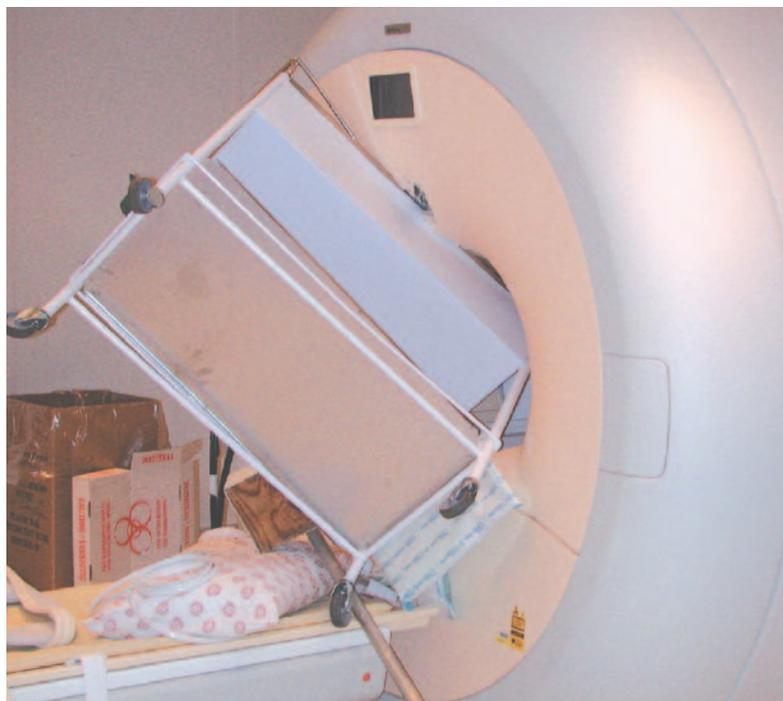
This effect is generally attendant upon ferromagnetic materials and the static field generated by an MRI system, and often manifests as the missile effect, which can involve non-compatible objects, such as wheel chairs, transport stretchers, file cabinets, electrical equipment and tools, powered and unpowered hand tools, stethoscopes, medical equipment carts, medical equipment (pulse oximeters, EKG, IV pumps, etc), communications devices, physician beepers, and miscellaneous (and often forgotten) patient and visitor objects that include hairpins, paper clips and pens.

A hairpin or paper clip within the 5-10 gauss line range could reach a velocity of 40 mph and will be attracted to the center of the MRI generated field (*x, y and z axis*) where the lines of force are equal.

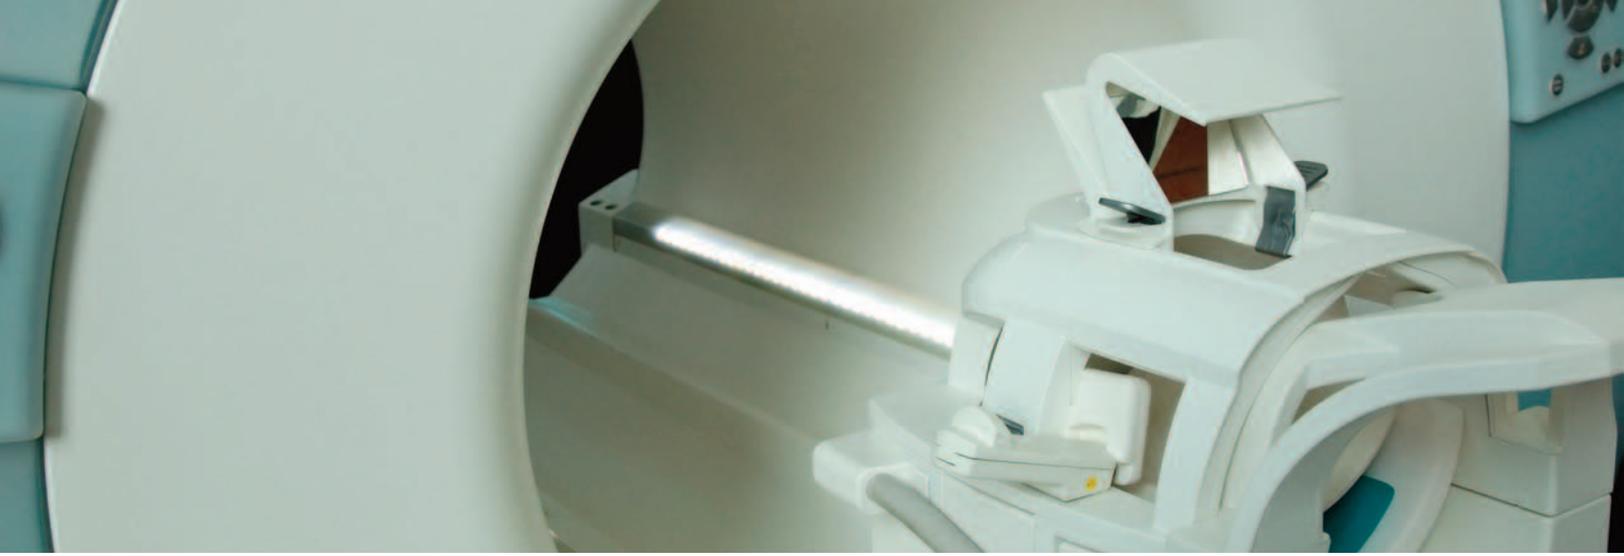
Torque forces run parallel to the translational force. Both are associated with ferromagnetic materials and the static field generated by an MRI machine. Attracted objects react by aligning parallel to the magnetic lines of force being generated by the MRI machine. The center of the MRI-generated field has the highest torque force, creating a serious exposure for all contraindicated items and MRI-conditional items in the MRI suite, depending on the tesla rating of the MRI. This effect has created life-threatening conditions for patients with some medical implants.

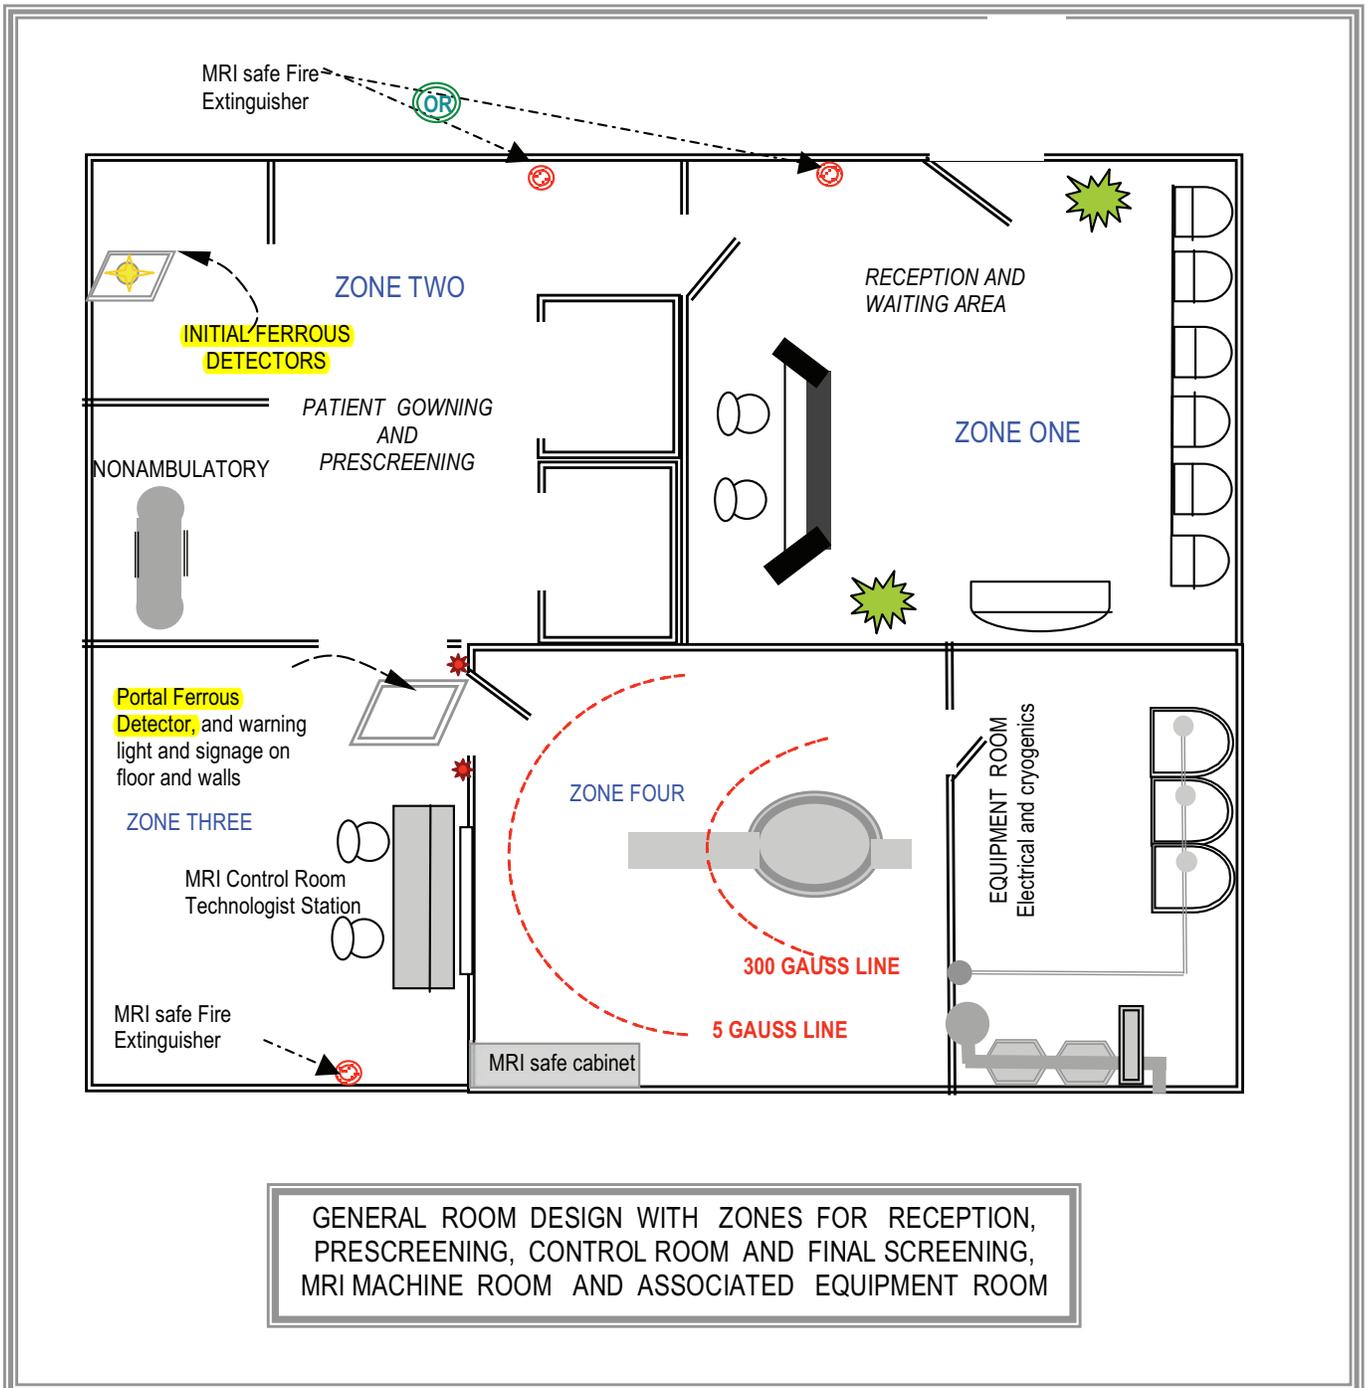
MRI best practices cover architectural, structural, equipment, HVAC, plumbing, electrical, life safety, energy conservation, communications, waste management and transportation. Our diagram of a typical arrangement, which is also the basis for the design of a mobile MRI unit, appears below. Details on RF shielding, gas monitoring, and pressure relief and other safety features are not shown in this basic scheme.

Architectural and design engineering for MRI suites has been established in standards published by the Joint Commission on the Accreditation of Healthcare Organizations (JACHO) and in American College of Radiology guidelines, as well as best practices in construction and design from the International Building Code, OSHA and other local and federal agencies.
