ACR Guidance Document on MR Safe Practices: 2013

Key Words: MR safety; MR; MR safe practices
J. Magn. Reson. Imaging 2013; 000:000–000.
 © 2013 Wiley Periodicals, Inc.

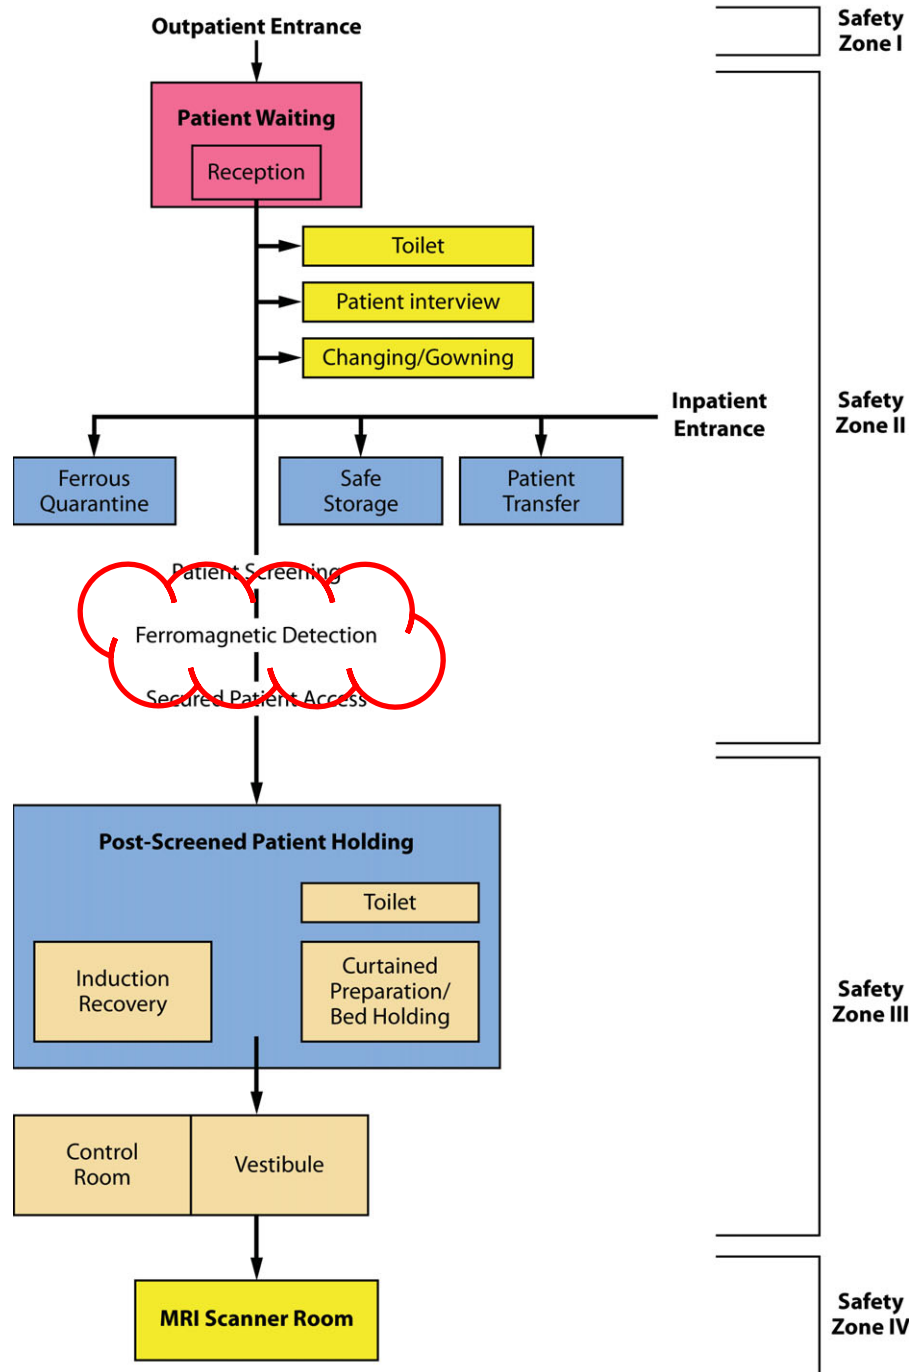
MRI Functional Diagram

Figure 1. Idealized sample floor plan illustrates site access restriction considerations. Other MR potential safety issues, such as magnet site planning related to fringe magnetic field considerations, are not meant to be include herein. See Appendix 1 for personnel and zone definitions. Note—In any zone of the facility, there should be compliance with Health Insurance Portability and Accountability Act (HIPAA) regulations in regard to privacy of patient information. However, in Zone III, there should be a privacy barrier so that unauthorized persons cannot view control panels.

Note: In any zone of the facility, there should be compliance with HIPAA regulations in regard to privacy of patient information. However, in Zone III, there should be a privacy barrier so that unauthorized persons cannot view the control panels. Please note that this diagram is an example intended for educational, illustration purposes only. The MR Functional Diagram was obtained from and modified with the permission of the “Department of Veterans Affairs Office of Construction & Facilities Management, Strategic Management Office”.

The MR site is conceptually divided into four Zones [see Fig. 1 and Appendices 1 and 3]:

- d. Zone IV: This area is synonymous with the MR scanner magnet room itself, i.e., the physical confines of the room within which the MR scanner is located (see Appendix 3). Zone IV, by definition, will always be located within Zone III, as it is the MR magnet and its associated magnetic field that generates the existence of Zone III. Zone IV should also be demarcated and clearly marked as being potentially hazardous due to the presence of very strong magnetic fields. As part of the Zone IV site restriction, all MR installations should provide for direct visual observation by level 2 personnel to access pathways into Zone IV. By means of illustration only, the MR technologists would be able to directly observe and control, by means of line of site or by means of video monitors, the entrances or access corridors to Zone IV from their normal positions when stationed at their desks in the scan control room.
